Department of Environmental Protection	GENERAL INSPECTION REPORT	Bureau of Land Recycling and Waste Management
---	------------------------------	--

Type of Inspection Complaint/Follow-up	WM Identification Number	Entry Time/Date 04/11/14	Inspection ID
Facility/Incident Name and Location Nutra Soils, Inc./ H.M.R. (Site 1) and H.M.R. Site 2			Municipality London Grove Twp.
E. Baltimore Pike Avondale, PA 19311			County Chester
Name, Address of Responsible Official Carlos Tenorio		Title Manager	
		Telephone 610-869-7645	Interviewed Yes <input checked="" type="checkbox"/> No <input type="checkbox"/>

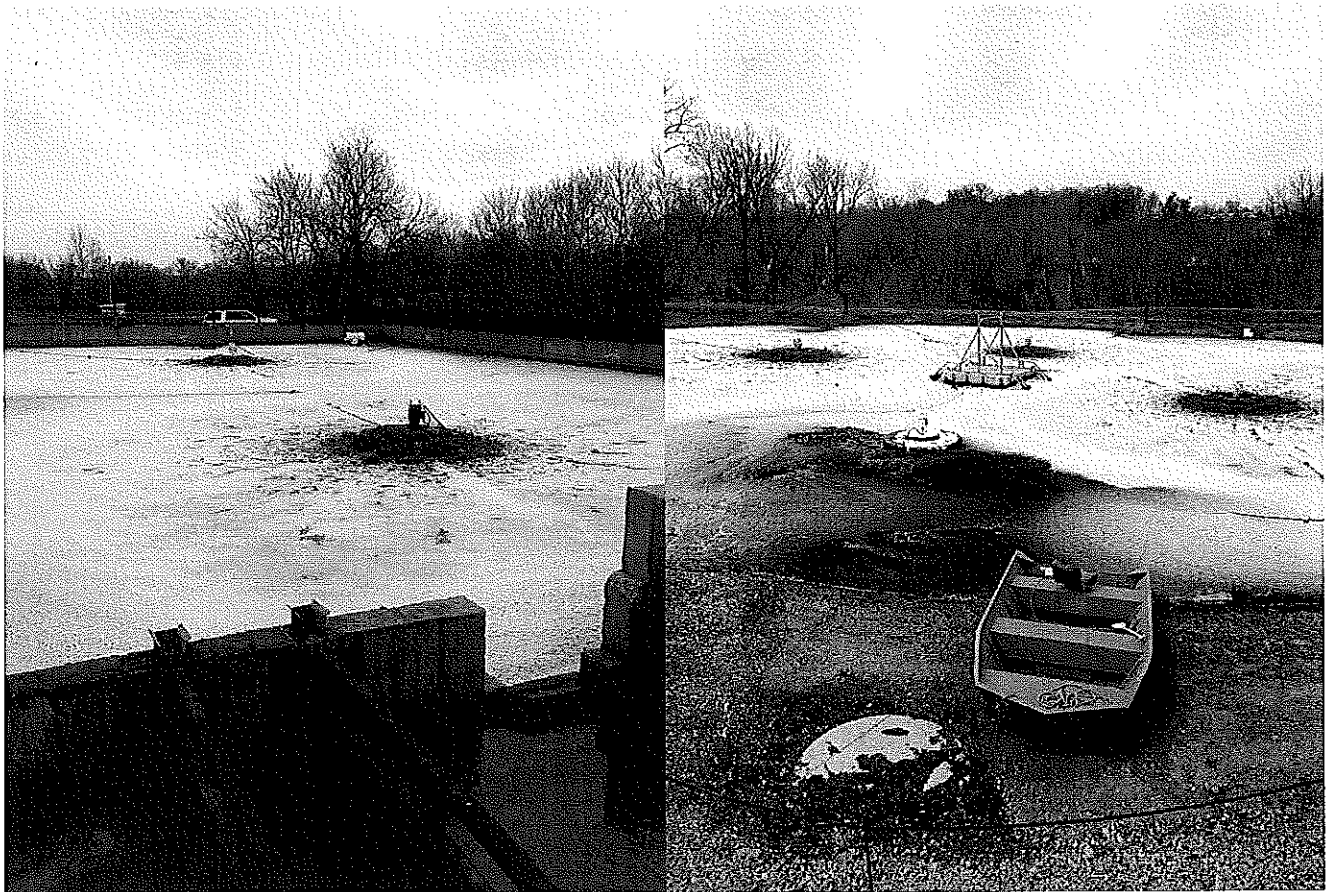
Both new aerators were running in the cement tank next to the wharf at Site 1. Three diffusers were running in the main lagoon. Mr. Tenorio plans to install three more diffusers in this lagoon. There was approximately 2' of freeboard in this lagoon at the time of the inspection. An *A J Hauling* tri-axle dump truck was being washed in front of the garage behind the office. Mr. Tenorio stated that about 4 trucks per week are washed in this area. This activity has been observed during prior inspections. Dirty water is not collected, it runs down the driveway and along the railroad tracks that cut through the property. The facility is recommended to perform vehicle washing in dedicated areas (indoors wherever possible) and to collect and manage wash water separately from storm drainage.

New aerators being utilized in the wastewater collection areas off the fresh substrate wharfs at Sites 1 and 2.

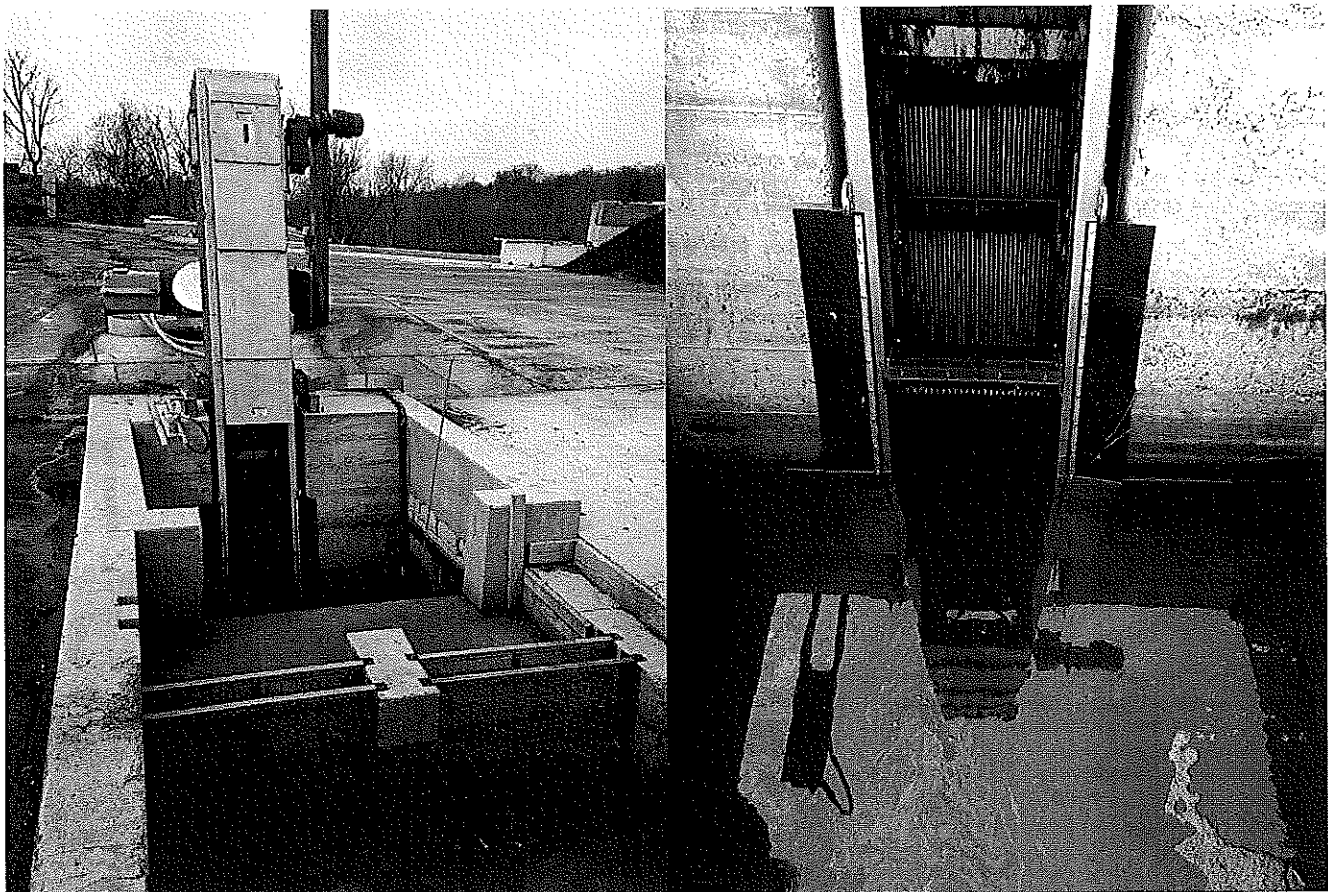
New automatic screen system to prevent solids from entering the wastewater lagoon at Site 2.

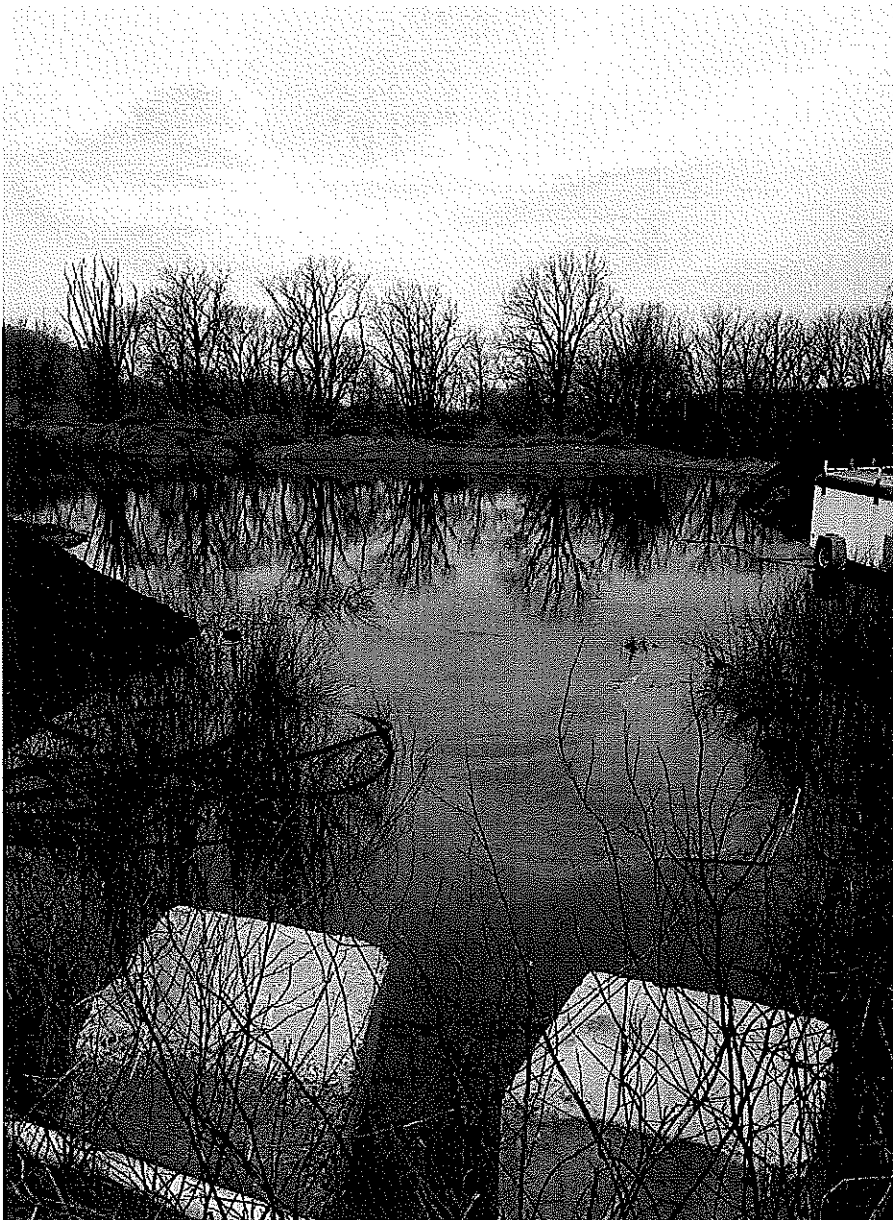
Although the facility has done well by installing the new aerators and automatic screen, problems remain at the site. The spent mushroom compost storage area at Site 2 was observed. There were odors detected in this area. BMPs listed in the current MFEMP include a composting pad and collection basin. The MFEMP states that this pad was built with technical assistance from USDA- NRCS. It does not appear that either of these structures would meet current NRCS standards. The collection basin was beyond capacity at the time of the inspection. On the west side of the basin, a drainage swale was observed. This swale had not been observed during previous inspections. There were shovels and bags of potting soil in the swale. It was evident that mushroom compost laden runoff was discharging through this swale and into the stream. Mr. Tenorio stated that they had attempted to raise the berm to prevent the water from discharging. The best management practices implemented at this site are not sufficient to prevent contaminated runoff from leaving the property. This would also constitute an unpermitted discharge. This area should be a priority for improvement.

Mushroom compost storage area collection basin at Site 2

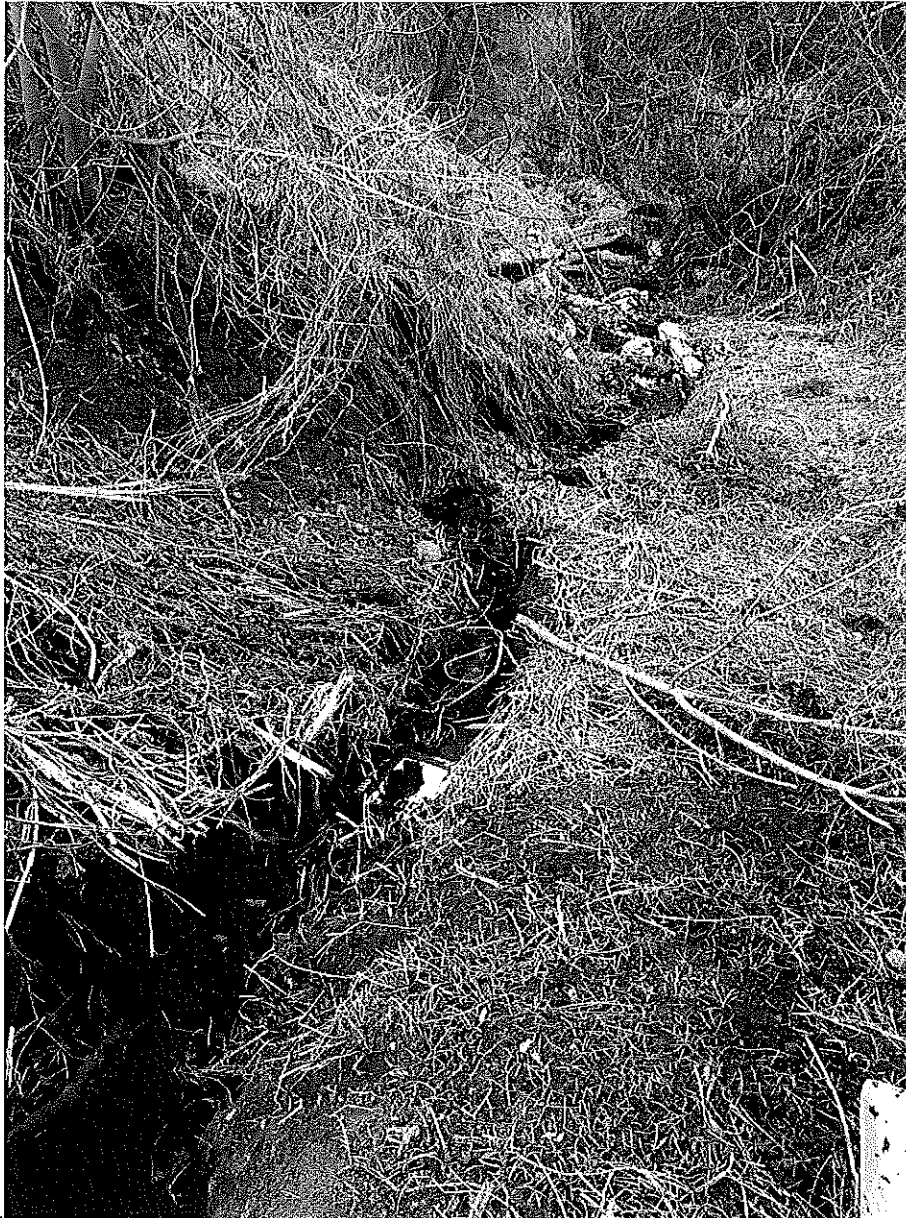
Mushroom compost laden runoff discharging into a drainage swale that leads to a stream.
