Traffic Report for Project Needs

PA 41 INTERSECTIONS STUDY Londonderry and London Grove Townships, Chester County

Prepared for:
**Pennsylvania Department of Transportation
Engineering District 6-0
7000 Geerdes Blvd
King of Prussia, PA 19406**

Erdman, Anthony and Associates, Inc.
One Sterling Place
100 Sterling Parkway, Suite 212
Mechanicsburg, PA 17050
717-766-1741
Fax: 717-766-5516

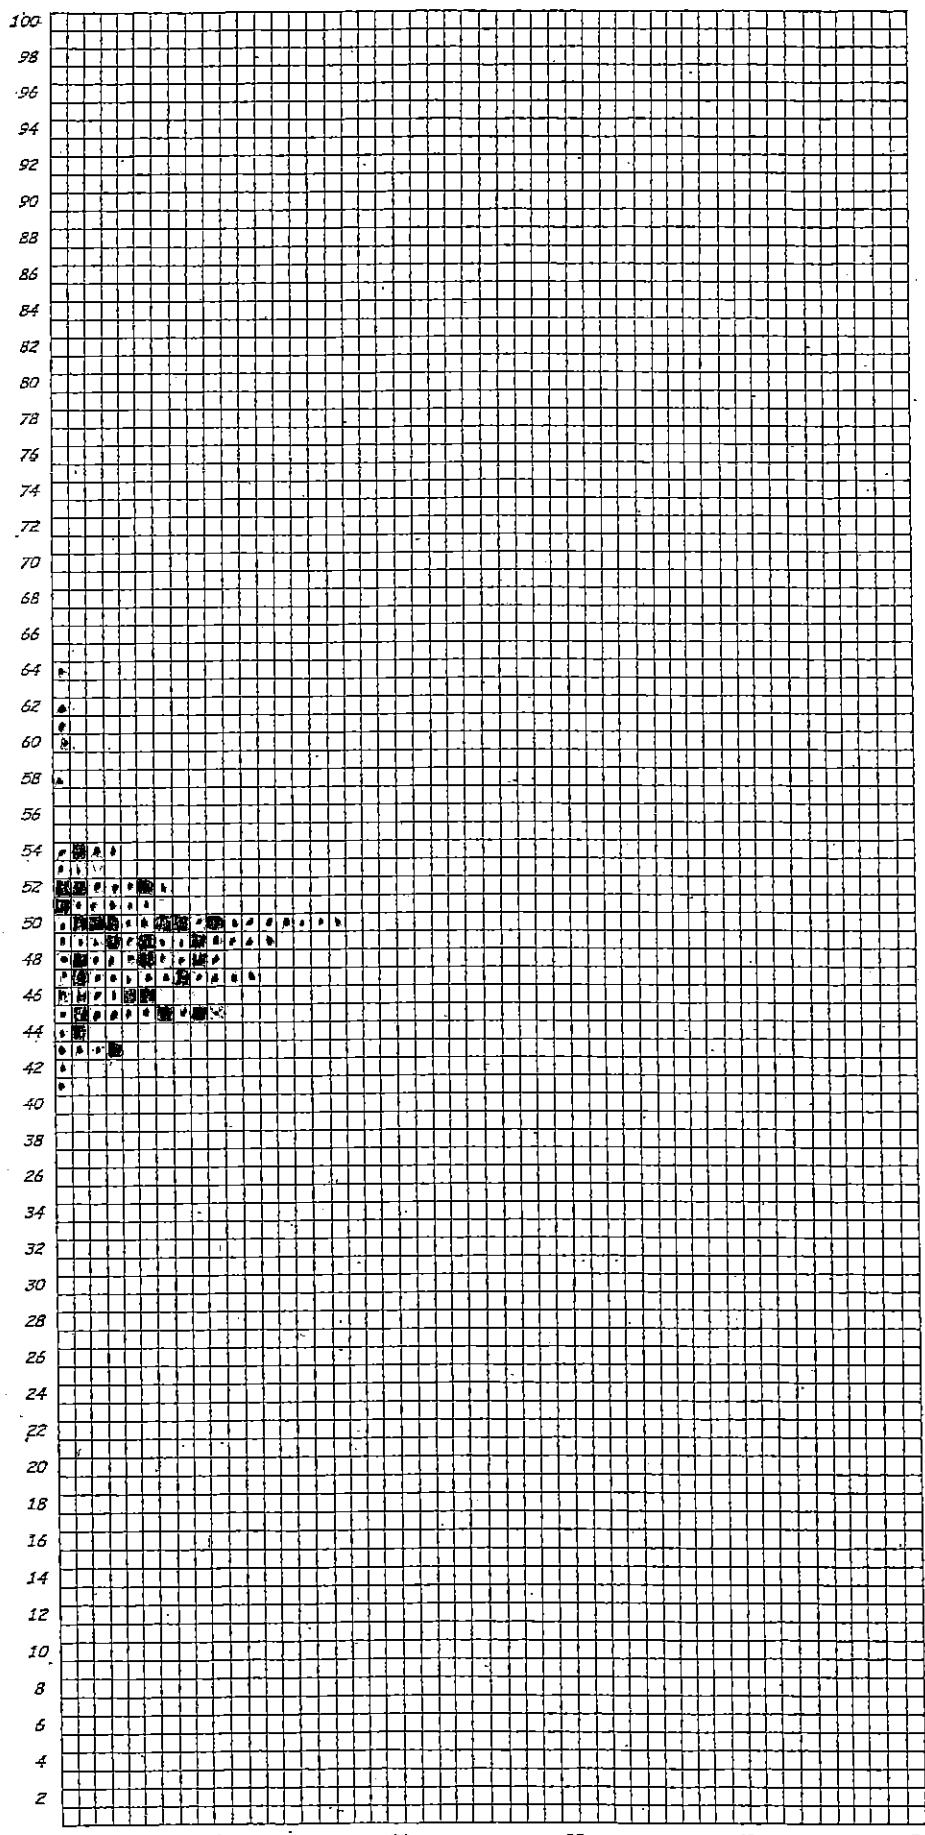
Date	<u>03/21/14</u>
County	<u>CHESTER</u>
Municipality	<u>LONDONDERRY</u>
Street Name	<u>GAT NEWPORT</u>
State Route	<u>0041</u>
Segment / Offset	<u>/</u>
Radar Location	<u></u>
Speed Limit	<u>45</u>
Pavement Type	<u>MACADAM</u>
Number of Lanes	<u>1</u>
Travel Direction	<u>N S E W</u>
Time Started	<u>11:15 AM</u> : PM
Time Finished	<u>11:50 AM</u> : PM
Weather	<u>Good</u>
Road Conditions	<u>Good</u>
Number of Vehicles	<u>100</u>
Pace	<u> </u> MPH to <u> </u> MPH

85th Percentile Speed

52 MPH

The speed study data can be found in Appendix E of this memorandum.

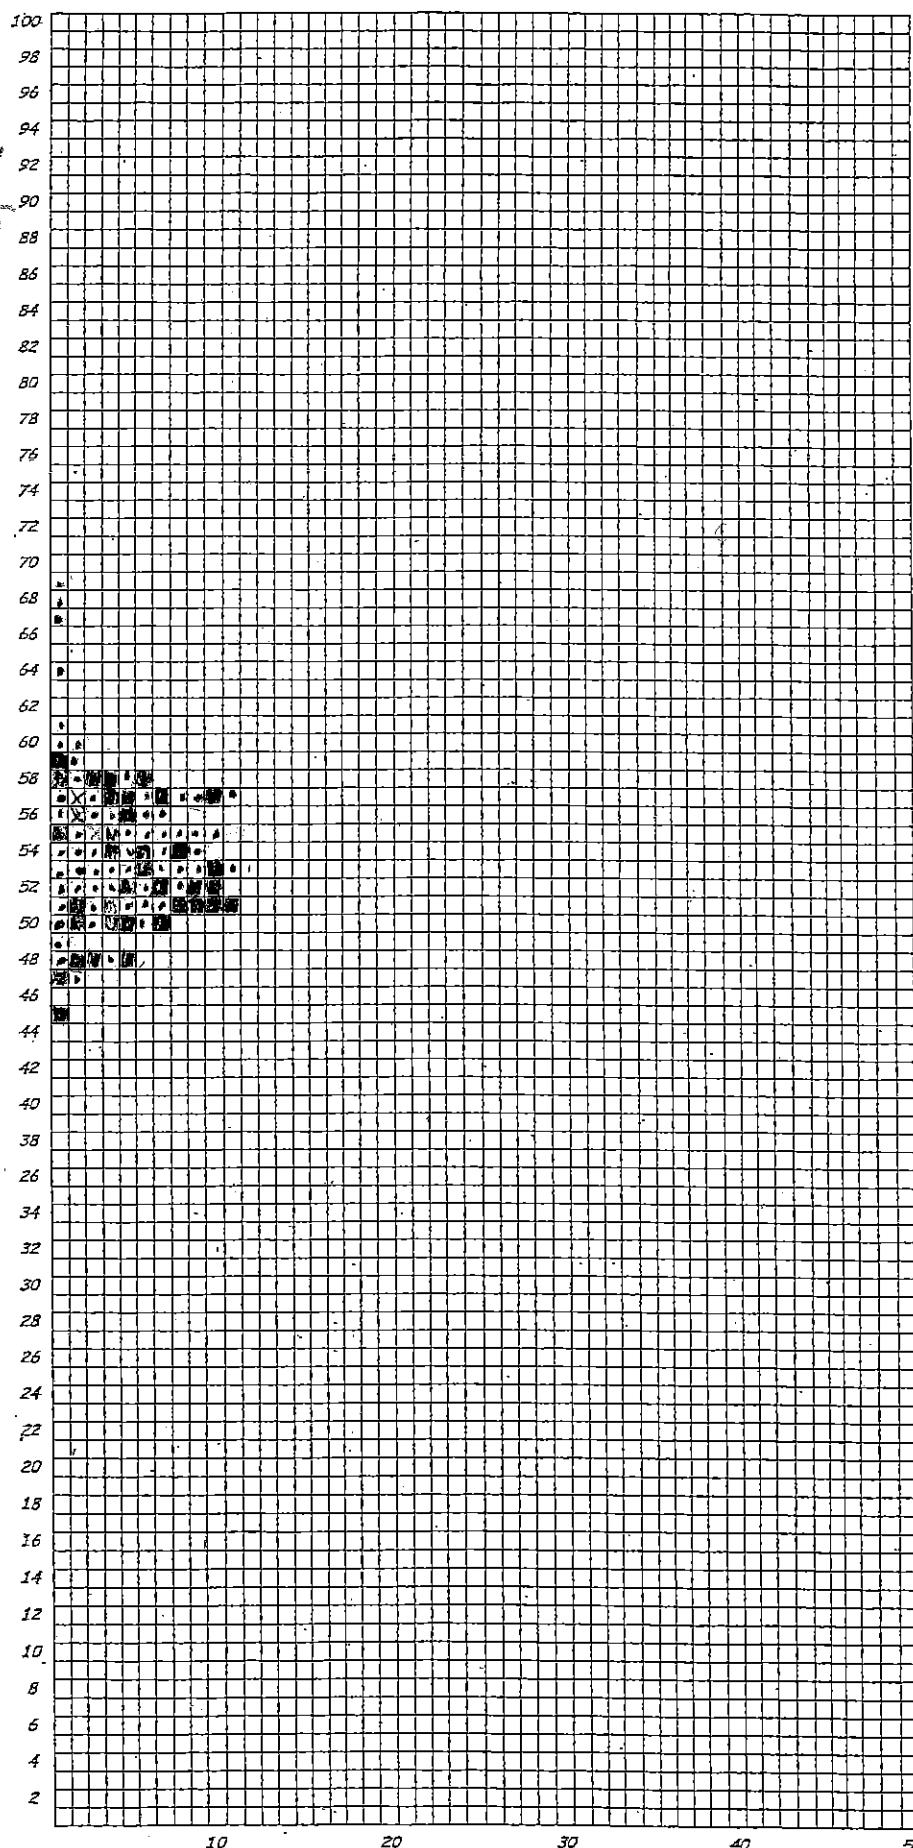
Date	<u>03/21/14</u>
County	<u>CHESTER</u>
Municipality	<u>LONDONDERRY</u>
Street Name	<u>CAP NWPOINT</u>
State Route	<u>0041</u>
Segment / Offset	<u>/</u>
Radar Location	<u>Intersection at 926</u>
Speed Limit	<u>45</u>
Pavement Type	<u>MACADAM</u>
Number of Lanes	<u>1</u>
Travel Direction	<u>N S E W</u>
Time Started	<u>10:00 AM</u> : PM
Time Finished	<u>11:00 AM</u> : PM
Weather	<u>Good</u>
Road Conditions	<u>Good</u>
Number of Vehicles	<u>100</u>
Pace	<u> </u> MPH to <u> </u> MPH

85th Percentile Speed
58 MPH

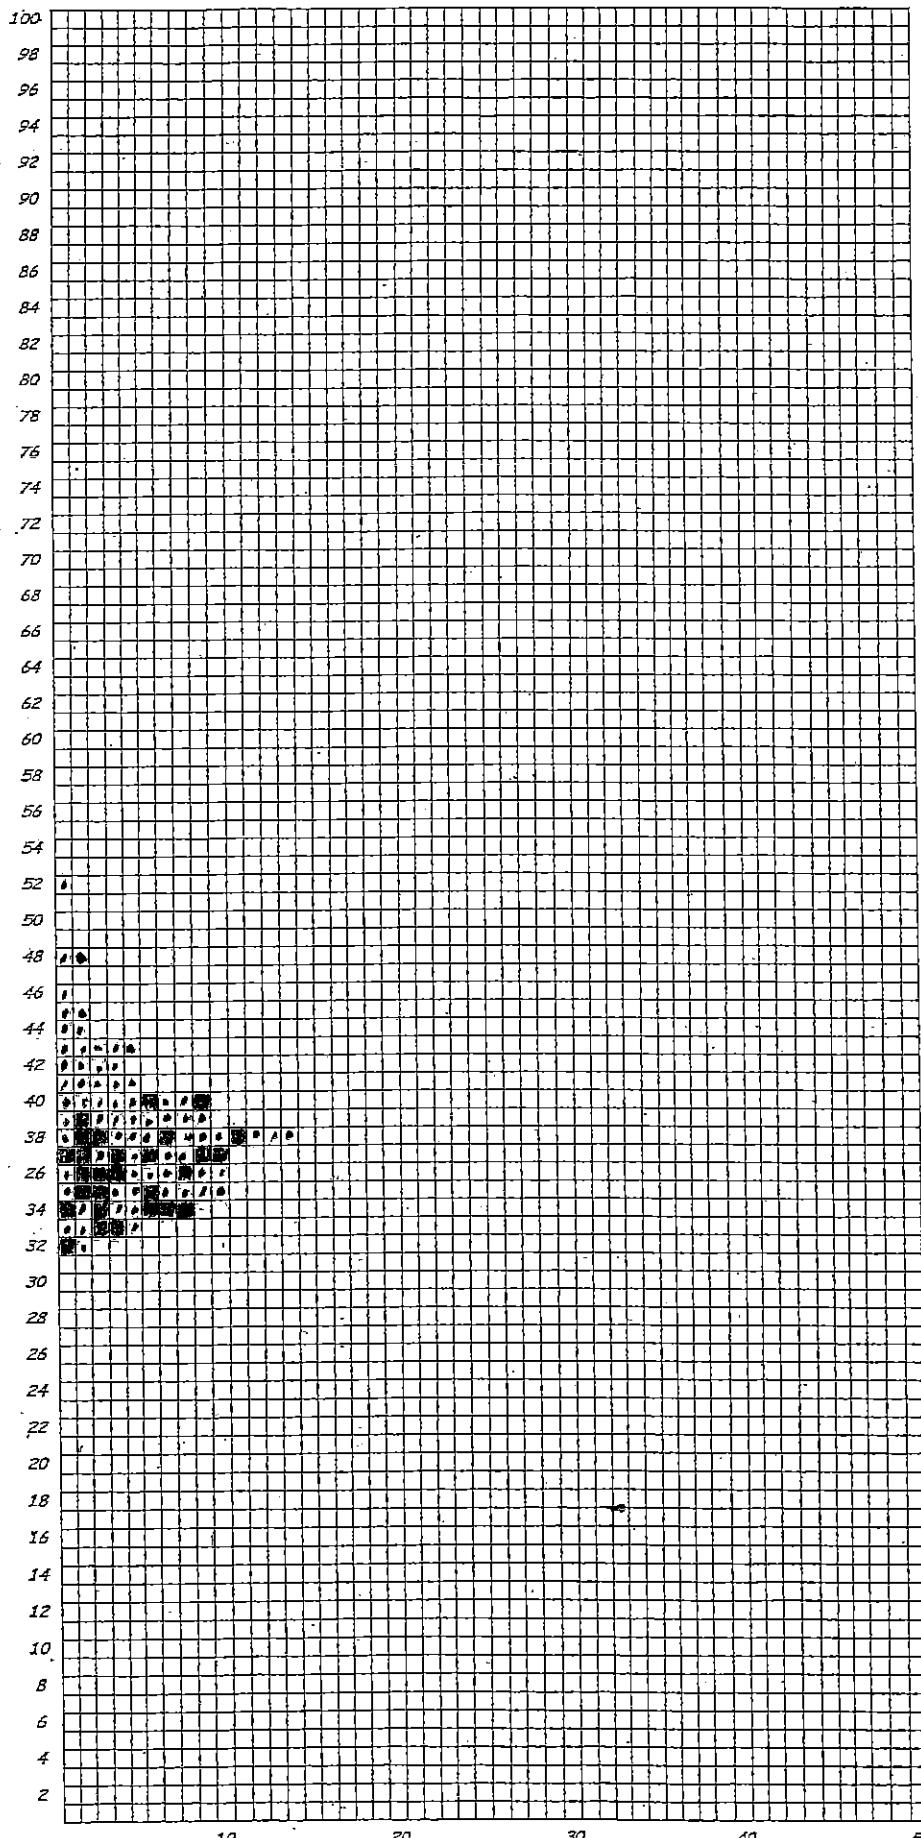
*SPEED DISTRIBUTION SURVEY
(Radar Survey)*

Date 03/26/14
County CHESTER
Municipality LONDON GENE
Street Name GAP NEWTON
State Route 0041
Segment / Offset /
Radar Location
Speed Limit 45
Pavement Type MACADAM
Number of Lakes 1
Travel Direction N S E W
Time Started : AM : PM
Time Finished : AM : PM
Weather Good
Road Conditions Good
Number of Vehicles
Pace MPH to MPH

42 MPH

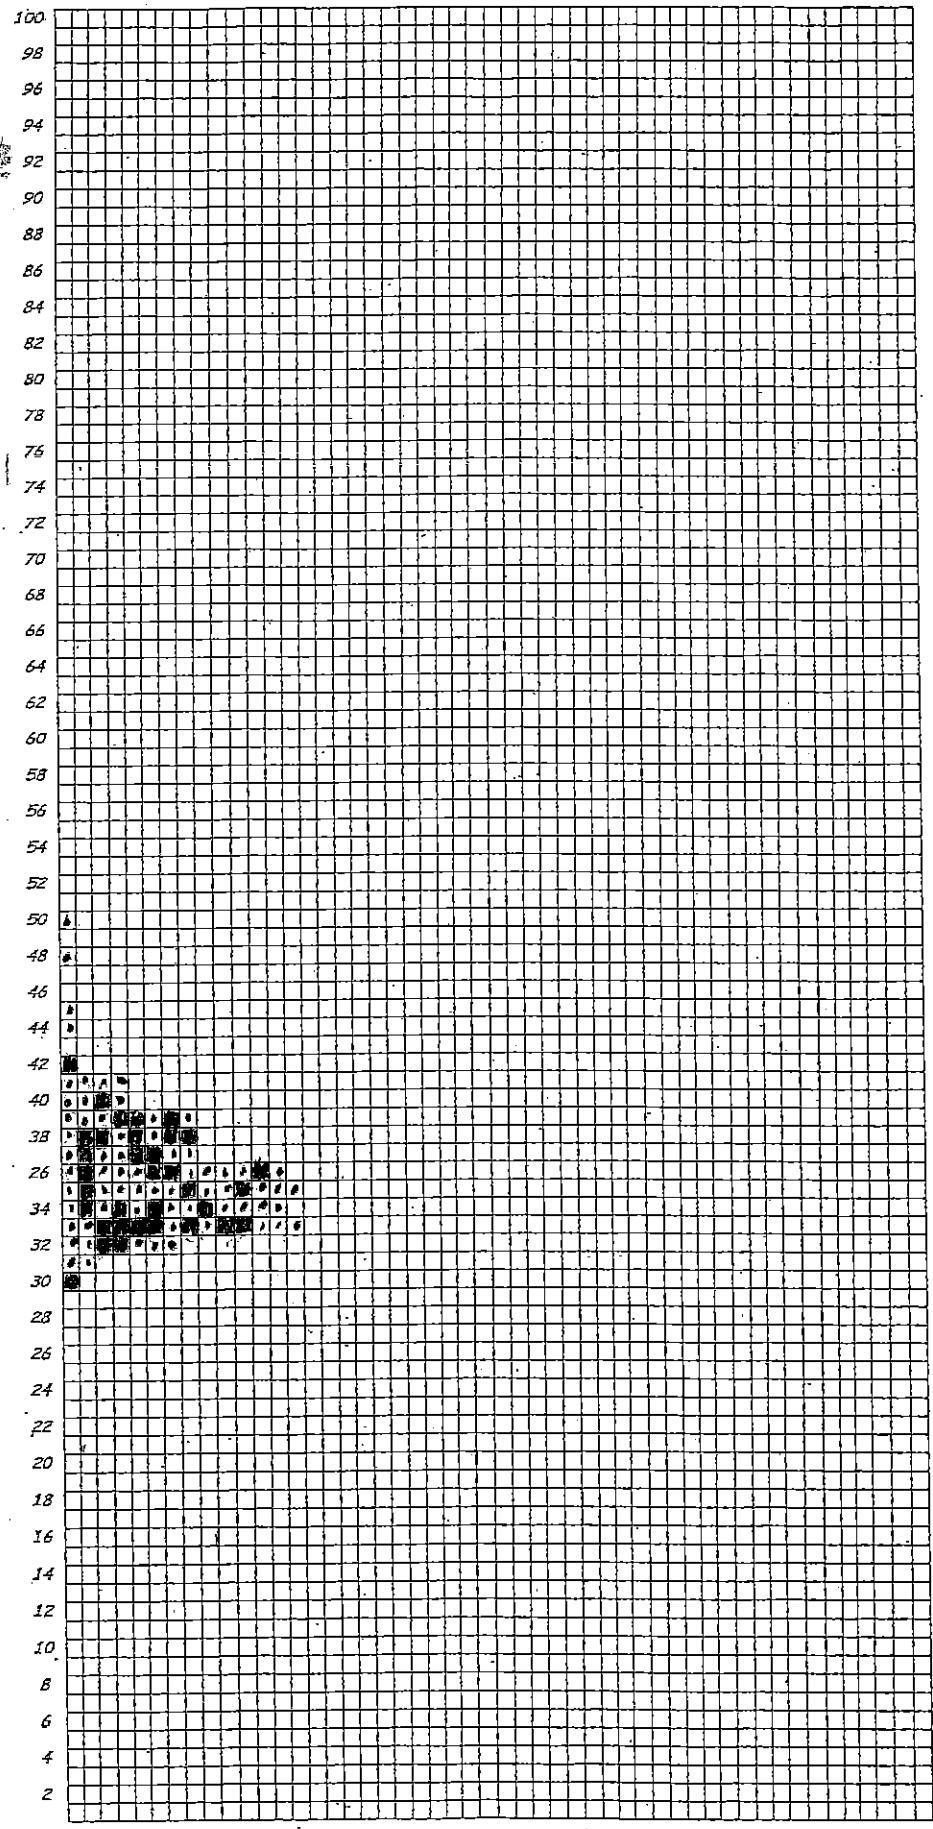
(3) SPEED DISTRIBUTION SURVEY
(Radar Survey)

Date	<u>03/26/14</u>
County	<u>CHESTER</u>
Municipality	<u>LONDON GRAVE</u>
Street Name	<u>CAP NEWPORT</u>
State Route	<u>0041</u>
Segment / Offset	<u>/</u>
Radar Location	<u>Intersection at SR 0811</u>
Speed Limit	<u>35</u>
Pavement Type	<u>MACADAM</u>
Number of Lanes	<u>1</u>
Travel Direction	<u>N S E W</u>
Time Started	<u>: AM 12:05</u>
Time Finished	<u>: AM 12:50</u>
Weather	<u>Good</u>
Road Conditions	<u>Good</u>
Number of Vehicles	<u>100</u>
Pace	<u> </u> MPH to <u> </u> MPH

85th Percentile Speed
39 MPH
